MICE Spectrometer Solenoid Repair

MICE Spectrometer Solenoids

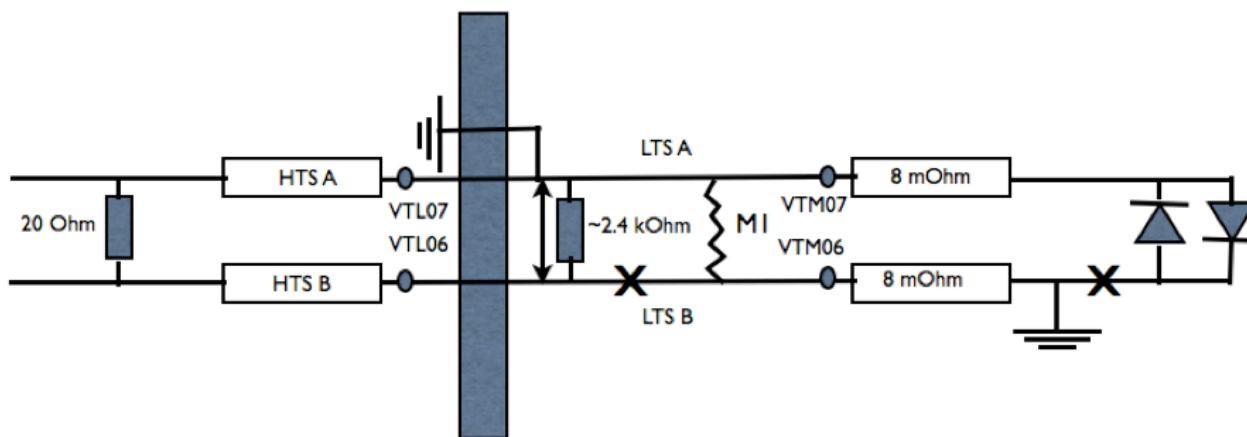
M1 circuit after fault

- However, upon entering the hall the odor of burnt FR4/G10 was extremely strong. Strongest at He relief valve
- After a great deal of analysis, it has now been determined that (see diagram on next slide):
 - One leg of M1 dead short to ground. This is LTSA lead.
 - LTSA lead not connected to coil (open), but connected to LTSA with $\sim 2.4\text{K}\Omega$ resistance.
 - M1 coil OK.
 - No damage seen anywhere else.
 - AC measurements show that QP on M1 not active indicating a break in the internal QP circuit. Most likely point is indicated in the figure on the next slide (x next to diodes) because there is another short to ground on this leg of the circuit.
 - All other coils OK (including their QP circuit).

Diagram of the M1 circuit. Resistance (four wire and two wire) measurements revealed:

- i) Lead A has hard short to ground,
- ii) LTSA is shorted to LTSA through 2.4 kOhms and LTSA is not connected to the M1 coil on the Lead B side.

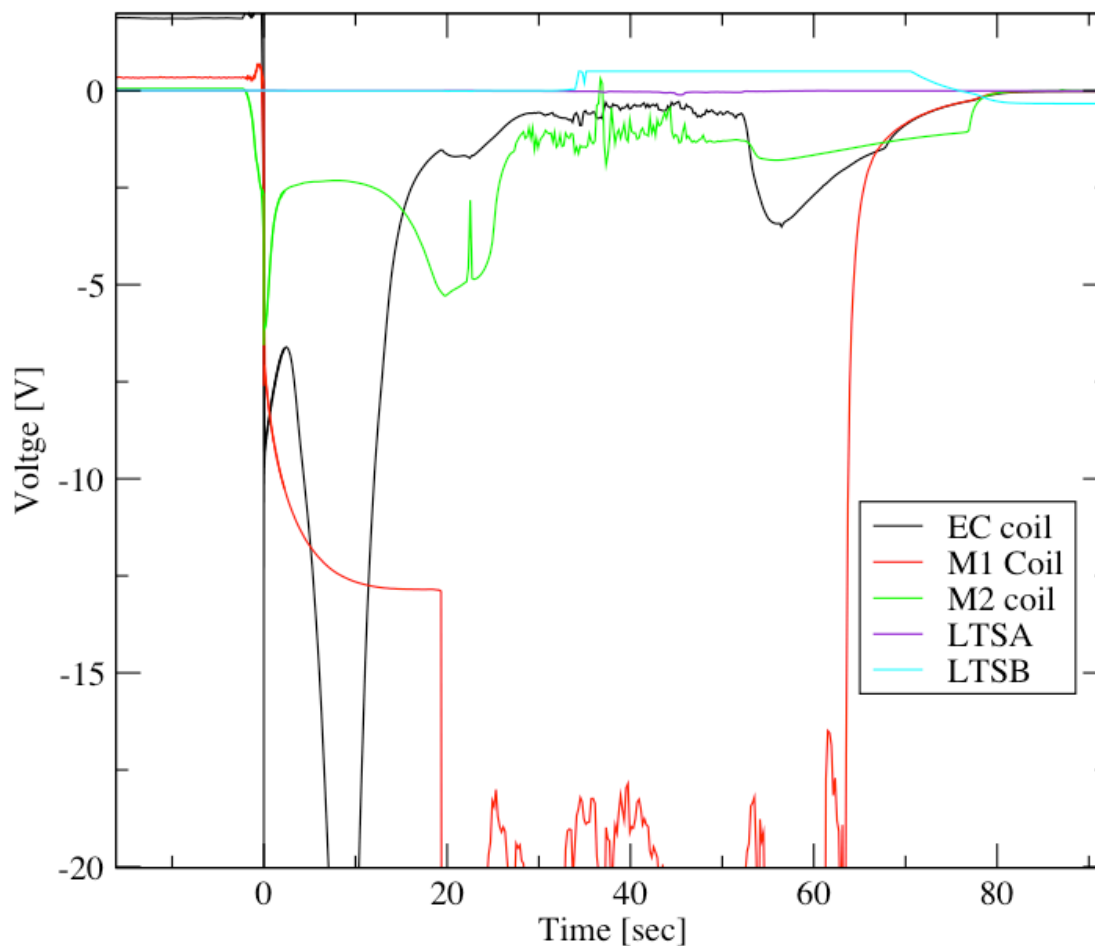
QP data – M1 (80 sec)

Quench on September 13th

- Quench initiated on ECE and initially proceeded normally
 - There is no evidence that any LTS leads were involved initially
- At ~ 20 sec, the internal QP for coil M1 failed
 - The voltage on the coil increased rapidly and, it appears that an arc at the LTS power feed through (from vacuum to LHe volume) occurred which burnt out the lead and effected M2 (the power leads for M1 and M2 utilize the same 4 pin feed through).
- What caused the QP failure?

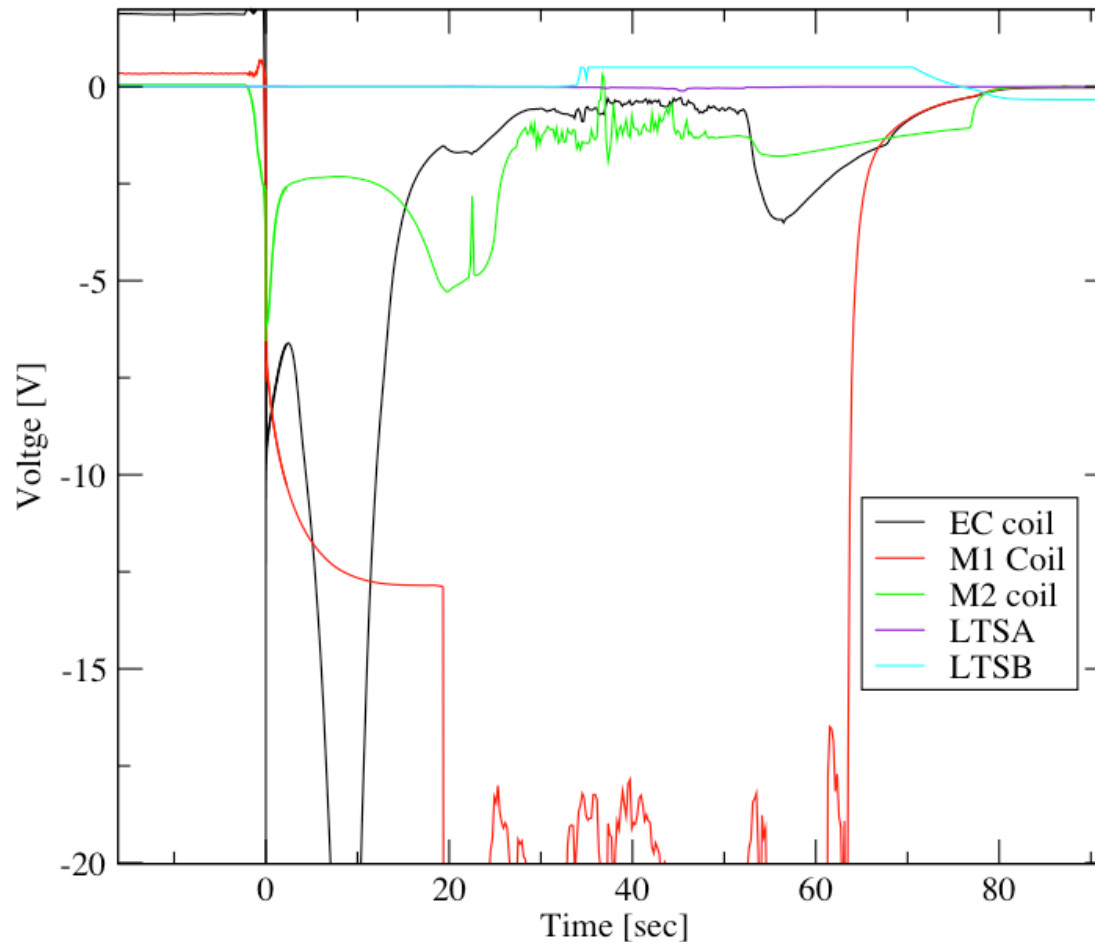
QP data – M1 (80 sec)

Expanded V scale

Quench on September 13th

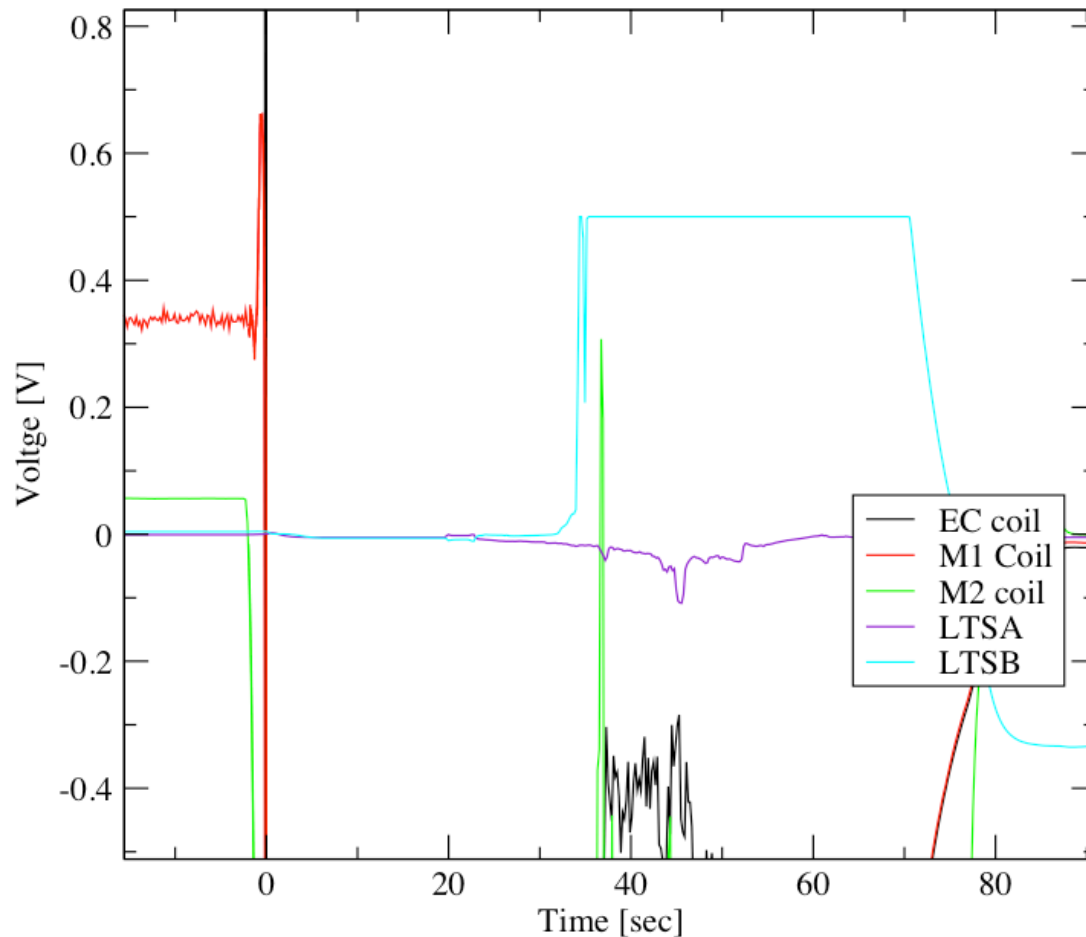
QP data – M1 (80 sec)

Expanded V scale II

Quench on September 13th

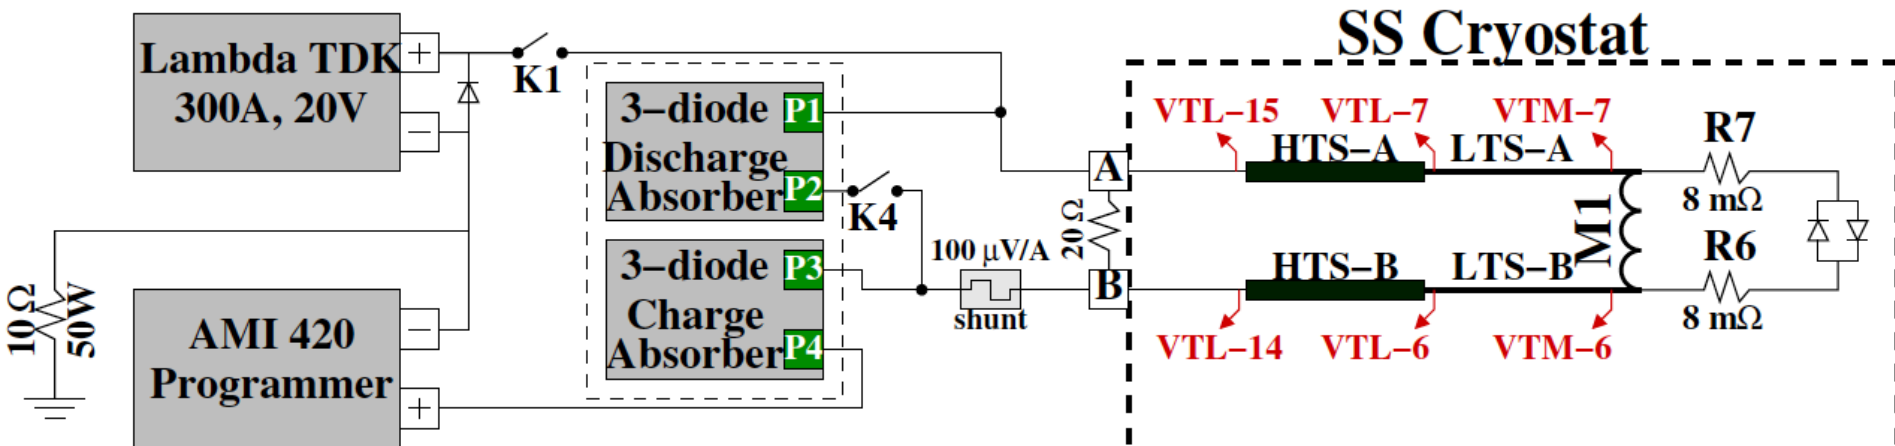
Circuit diagram

Failure in electrical circuit from the point of VTM-7 to VTM-6 as indicated in diagram on Slide 7

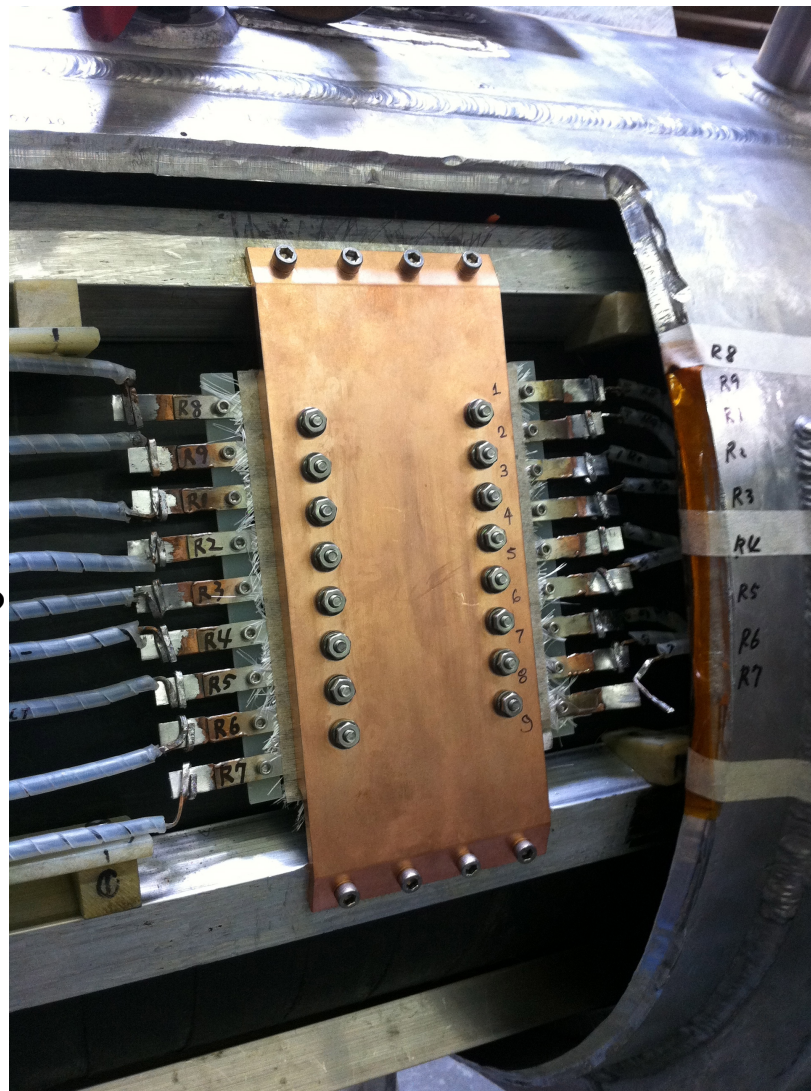
SSD/SS1

This is a photo of the QP pack for SSD/SS1. What is not known at this time is whether or not the terminations of the leads were complete when the photo was taken or exactly how the terminations were made. Did Wang follow the procedures used on SSU/SS1?
